PHASE I INSPECTION REPORT

NATIONAL DAM SAFETY PROGRAM

**CALOMA CREEK BASIN
JONES MEADOW DAM
GREENOUGH, MONTANA
MT-1159**

**MORRISON - MAIERLE, INC.
CONSULTING ENGINEERS**

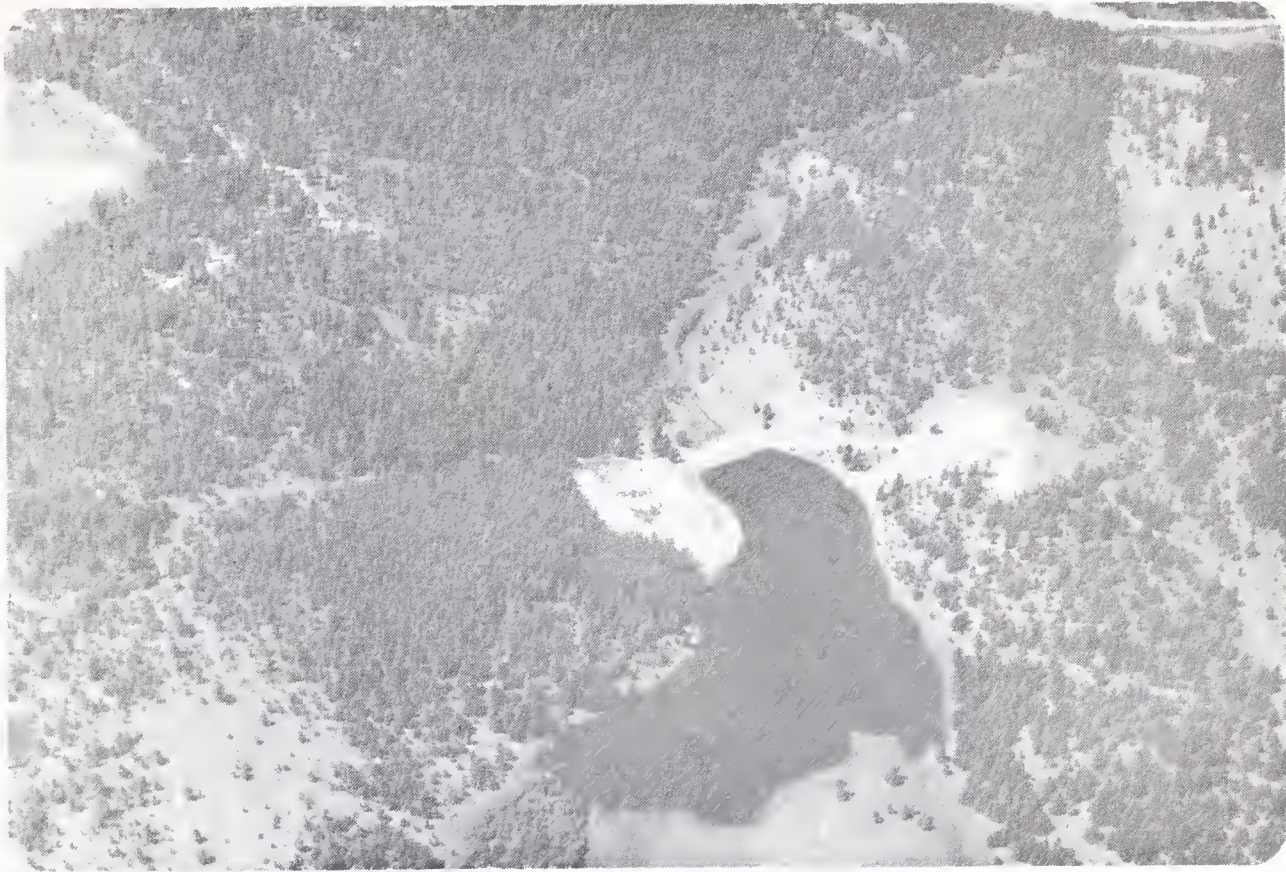
Photo 1 Aerial view of Jones Meadow Dam and Reservoir

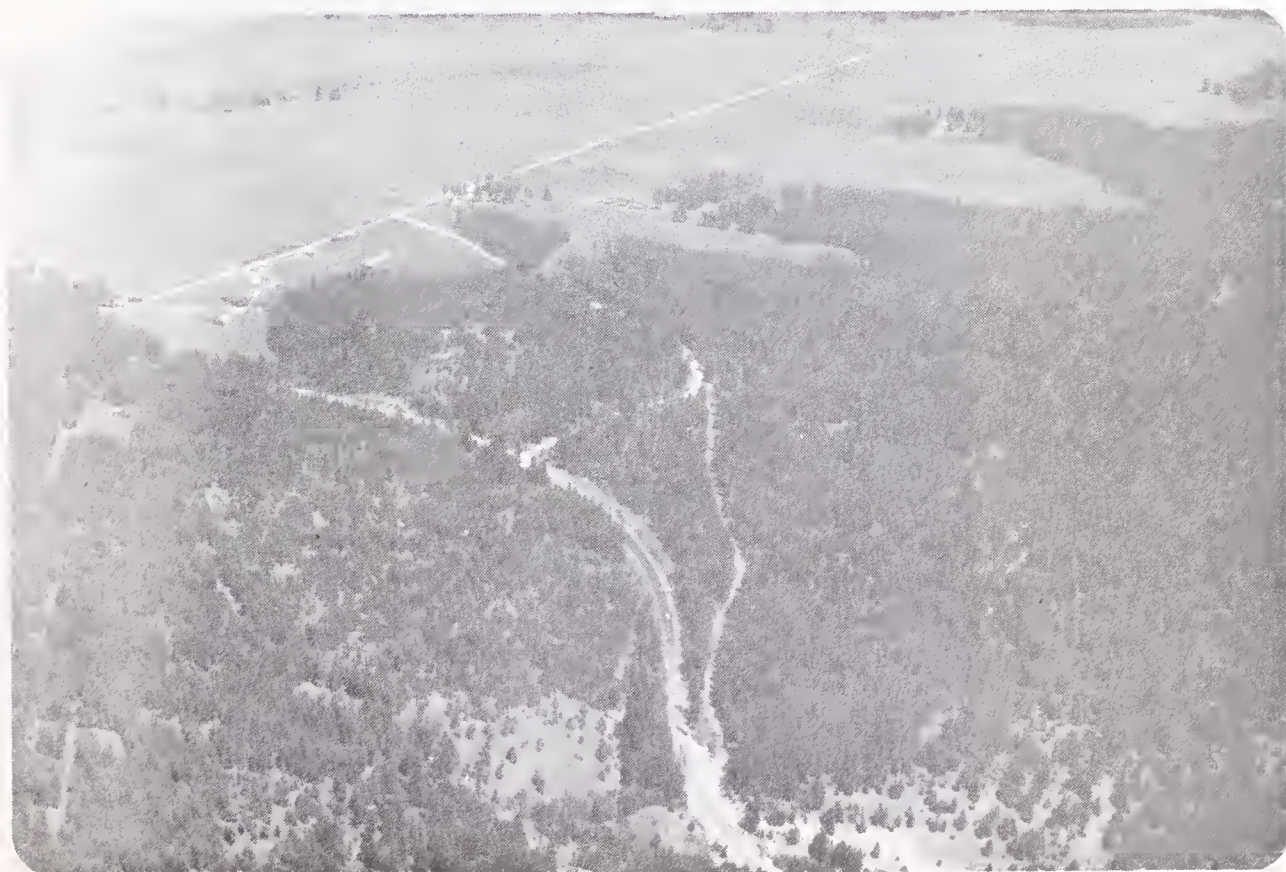
Based on visual reconnaissance and engineering judgement, approximately one residential home, several farm buildings, an old school house, the heavily traveled Montana Highway 200, and miscellaneous property would be affected by a sudden breach of Jones Meadow Dam. On the basis of this information and in accordance with the recommended guidelines, the project size is classified as small and the downstream hazard potential is high (Category 1).

Photo 2 Aerial view of Greenough Area Downstream of Dam

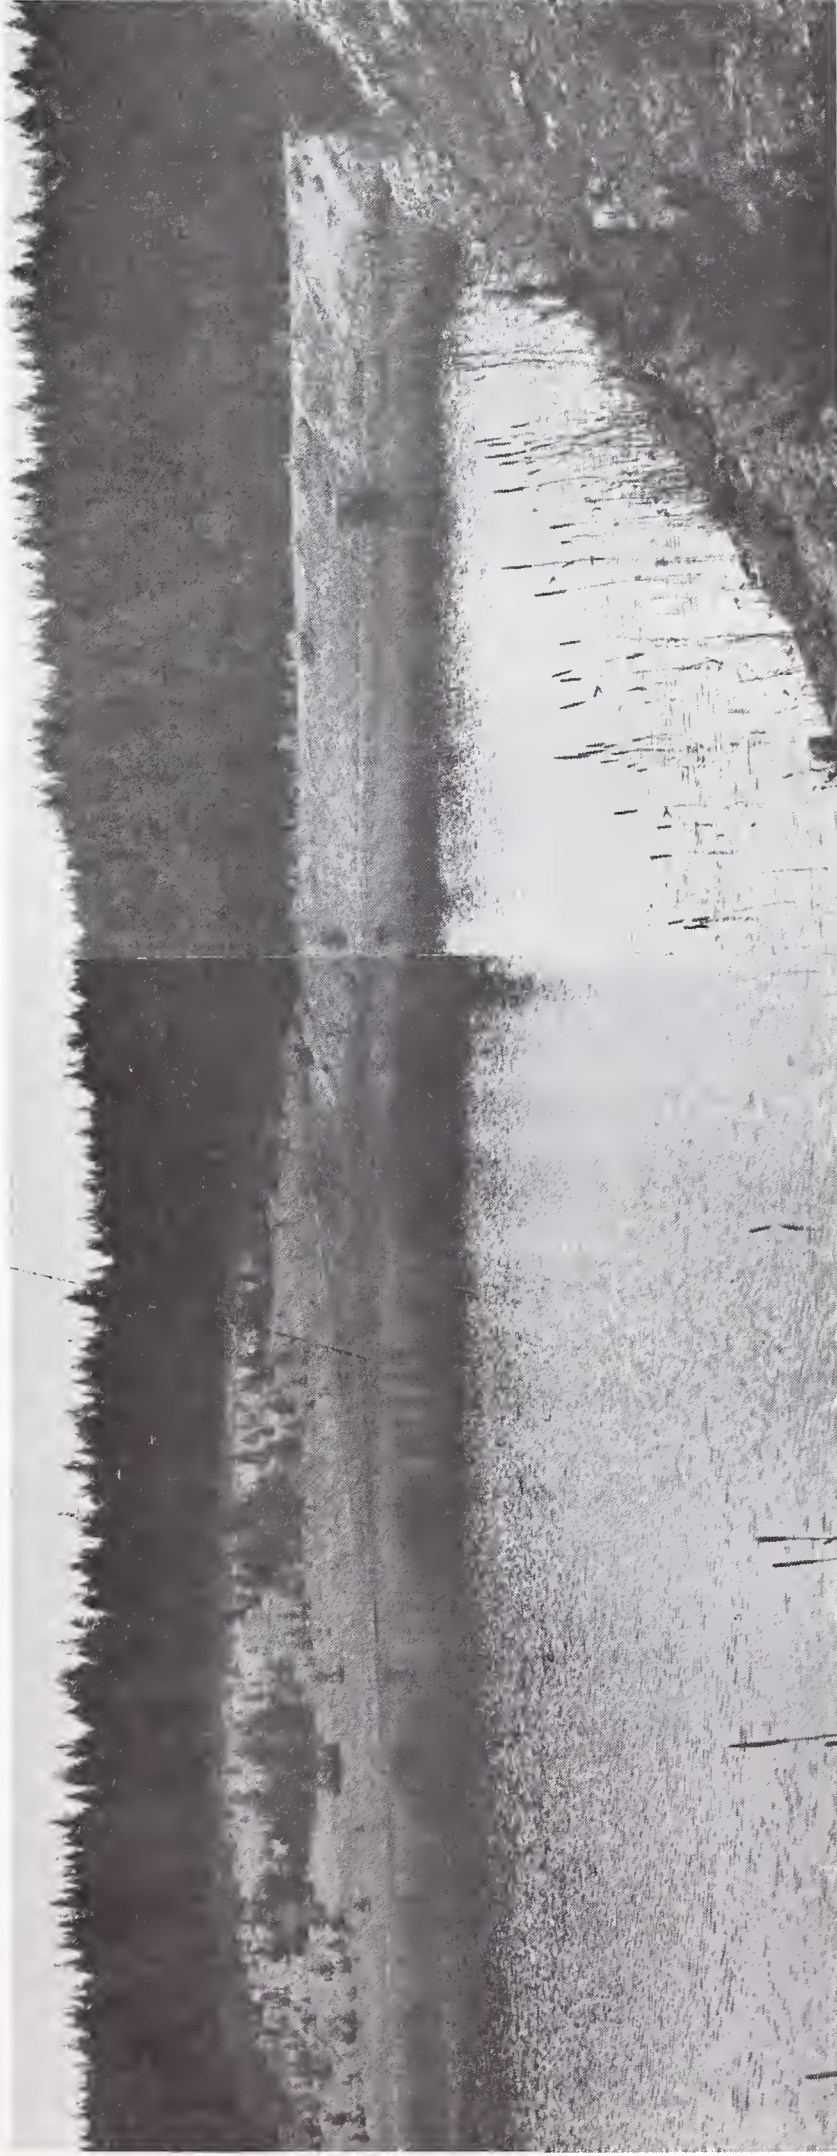
Photo 3 Upstream slope of Dam looking toward south abutment and spill-
way approach

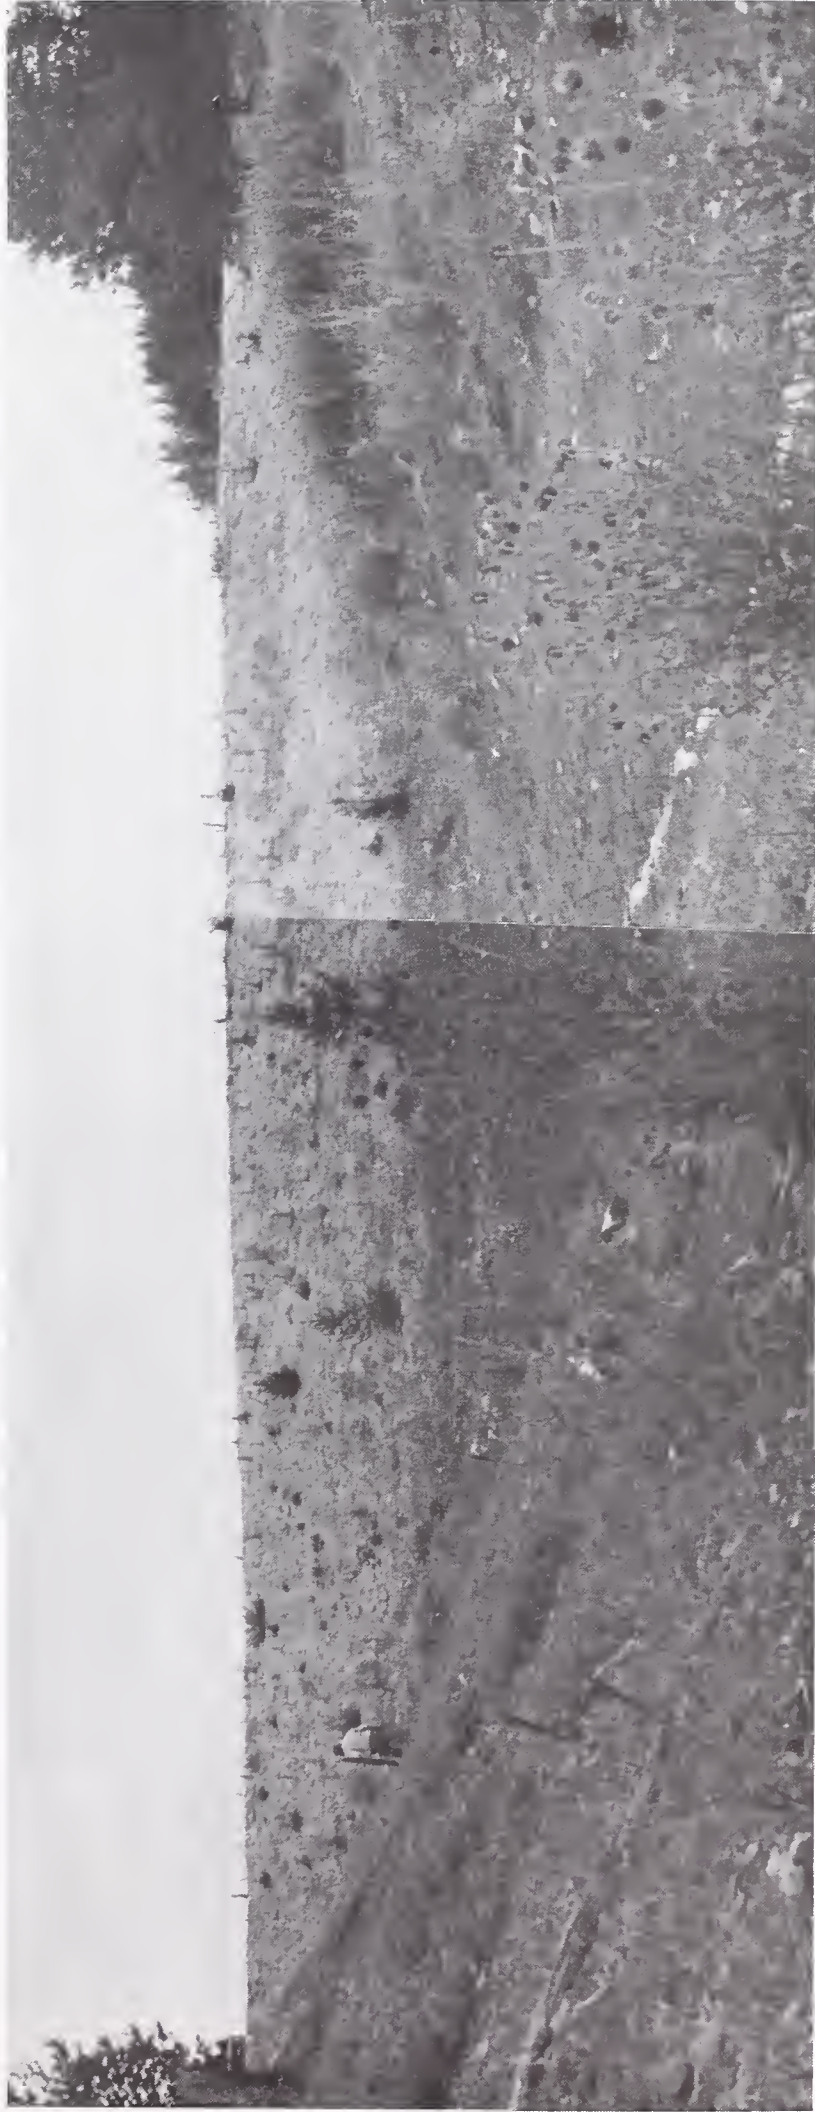
Field inspection reveals the dam embankment to be in good repair. There is no evidence of differential settlement, disturbance, misalignment, accelerated erosion, or slope failure in the embankment. Although there is no riprap protection on the upstream face, the prevailing wind direction is away from the dam and wave erosion of the embankment was not evident.

A visual inspection of Jones Meadow Dam revealed no longitudinal or transverse cracking. The downstream slope was uniform with no irregularities. A few scattered, small trees were present on the upstream and downstream slopes and in the emergency spillway channel. The reservoir level at the time of the inspection was 6.8 feet below the dam crest which corresponds to reservoir elevation 116.3 feet project datum (4028.3 feet NGVD). There is no wave erosion on the upstream slope and wave action would be directed away from the dam by the prevailing winds.

Photo 4 Downstream slope of Dam

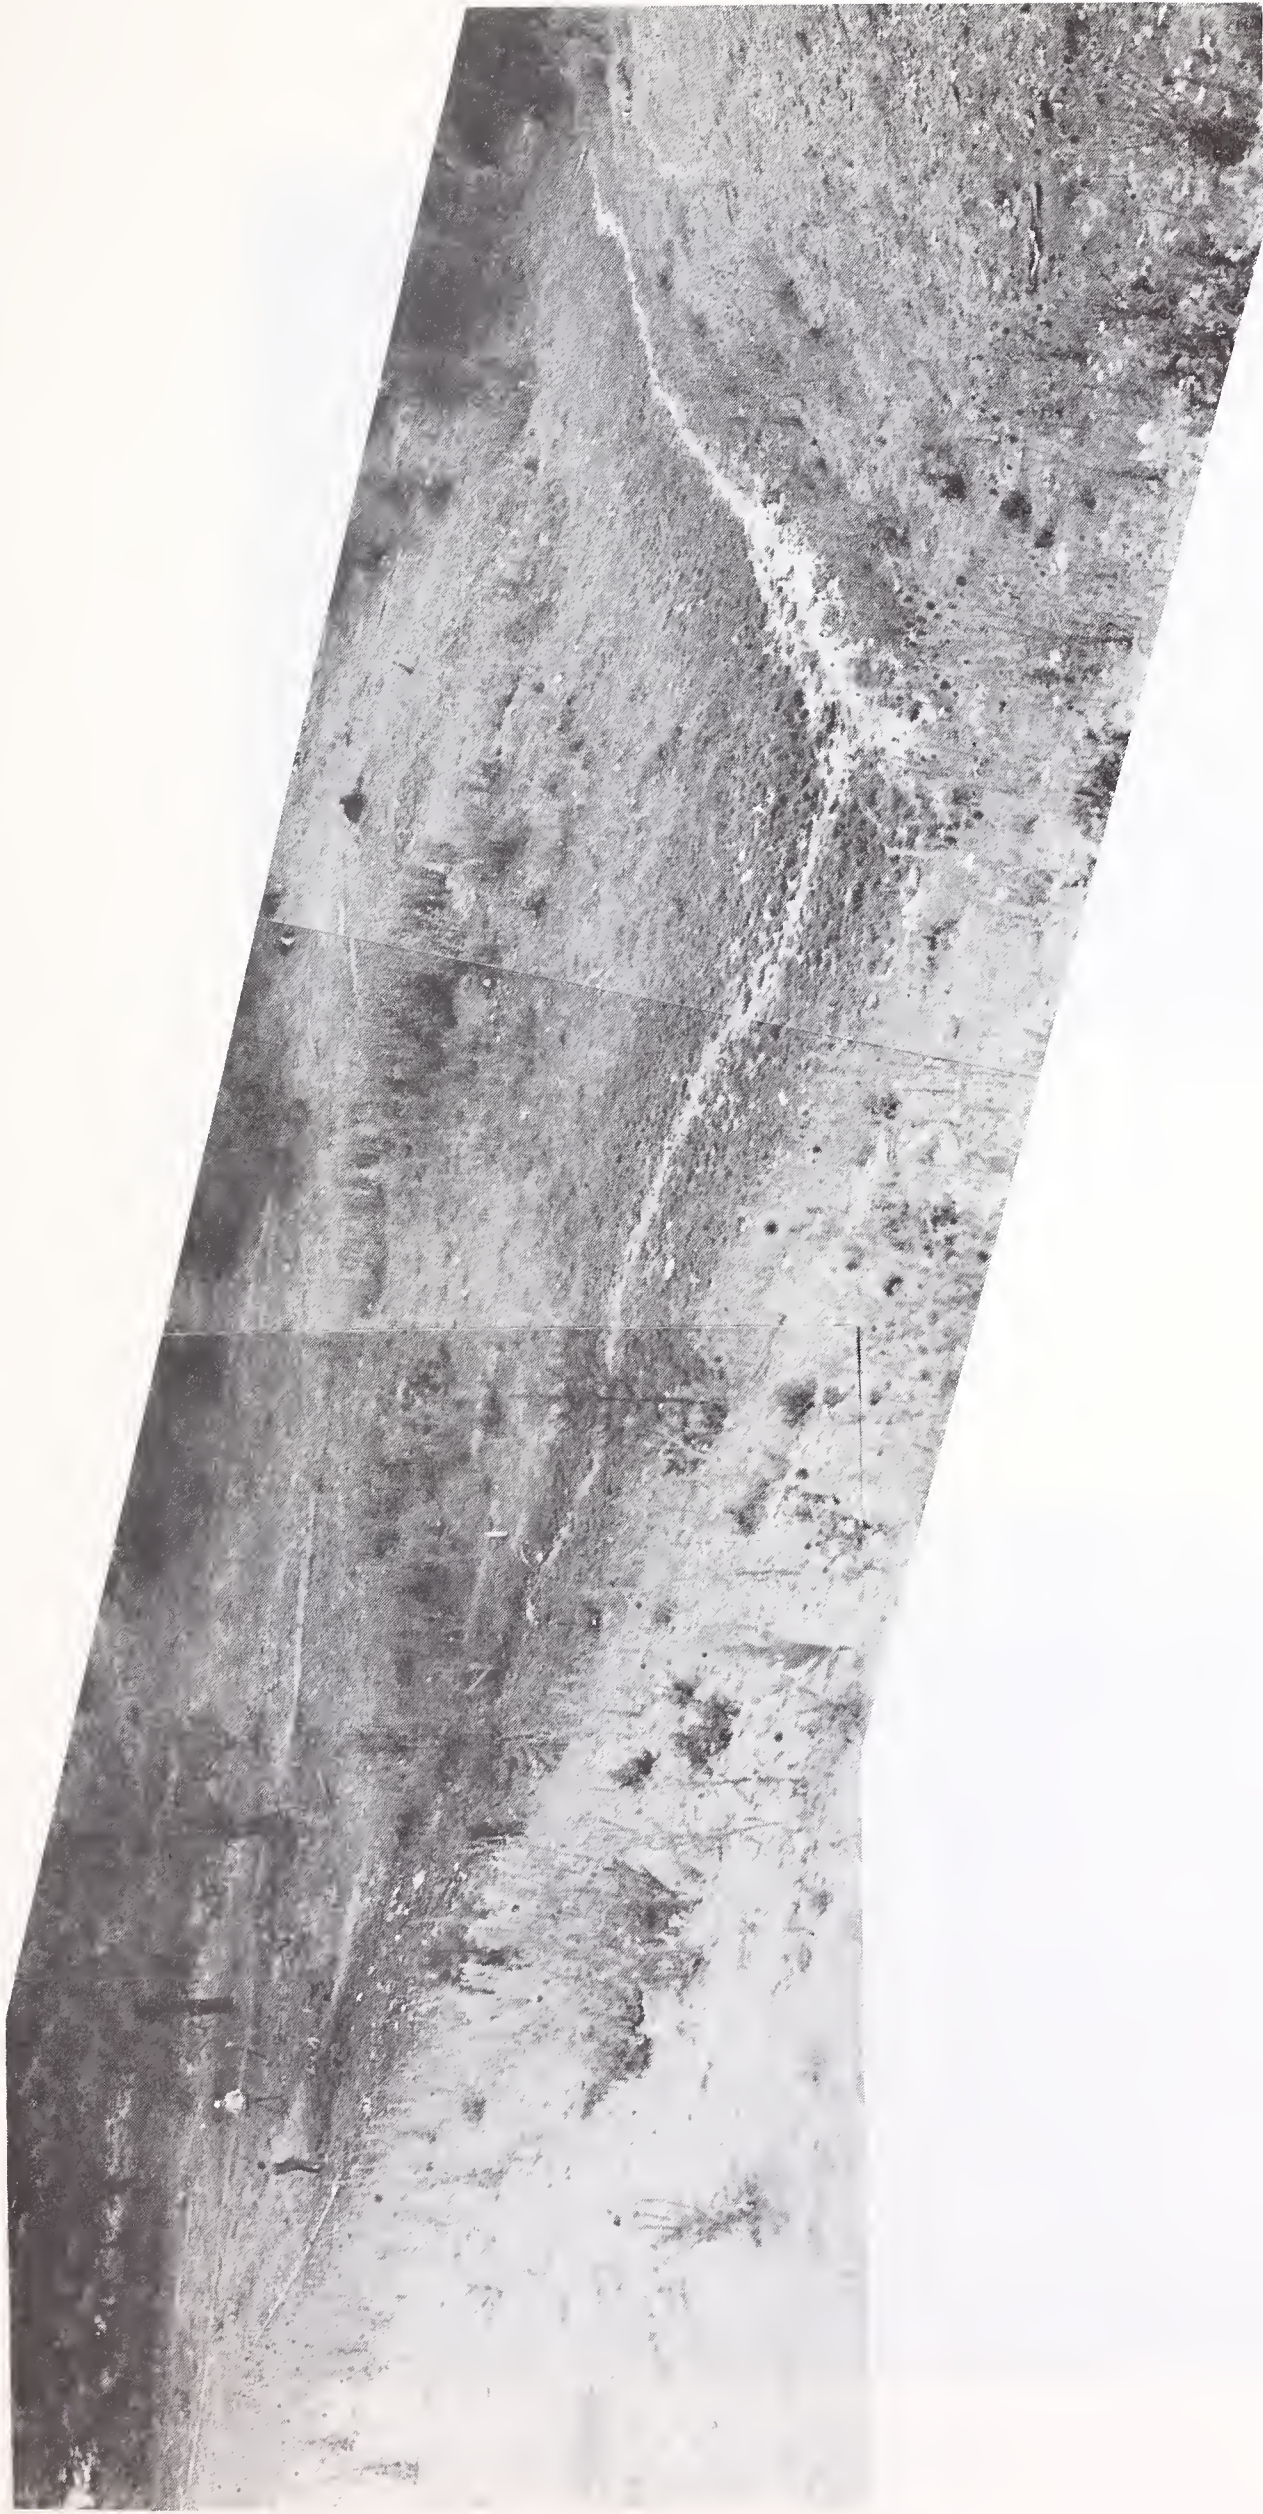
At the time of the July 17, 1980 field inspection, an estimated 100 gpm was flowing from a zone in the left abutment in which the highest water exit level elevation was 105.3 feet project datum (4017.3 feet NGVD). This seepage zone was less than three feet thick vertically, four to five feet wide, (Photos 5 and 6) and appeared to be confined to fractured bedrock in the abutment and did not include any of the embankment material. The observed seepage that was existing from the jointed bedrock abutments is discussed in the predesign memos (References 9, 10 and 11) and was anticipated prior to construction of the dam. The seepage observed on July 17, 1980 was clear and free of sediment or turbidity.

Photo 5 Downstream slope of Dam and channel area. Note seep area at south abutment

3. Inspect the low-level outlet gate and conduit and repair it, if required.
4. Inspect the condition of the impervious blanket seal, placed on the upstream face of the left abutment to control seepage and determine if it is functioning as intended. Note any changes in seepage conditions.

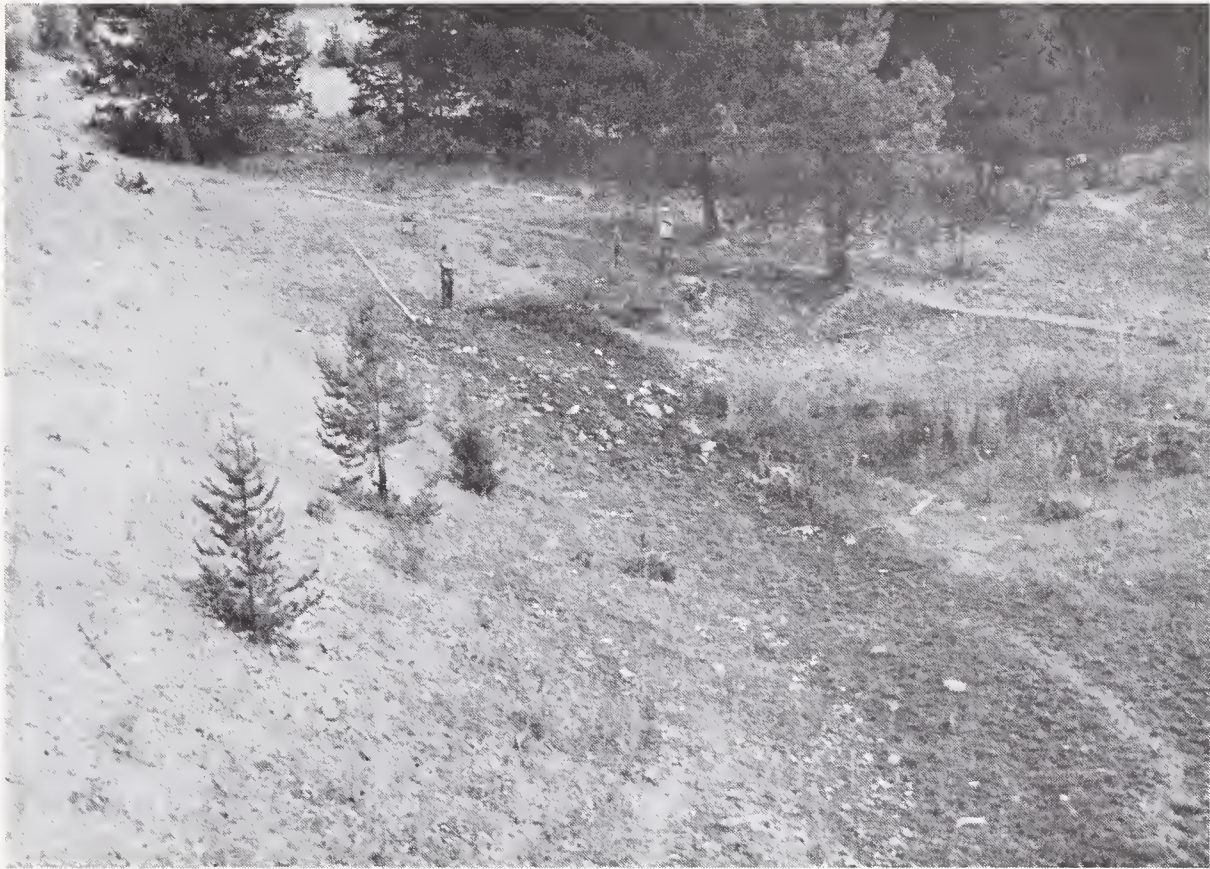
Field notes dated June 28, 1965 indicate that repairs had been completed by that date. The repairs consisted of the placing of an upstream blanket of impervious soil on the upstream portions of the right and left abutments. Field notes written subsequent to emplacement of the upstream blanket indicate that the seep in the left abutment continued in the same location; however, the repairs reduced the hydraulic gradient sufficiently to reduce or eliminate seepage pressures in the embankment material and there was no evidence of piping in the embankment material above the seep during the July 17, 1980 inspection.

The external geometry and materials used in the zoned earth dam may conform to recommended guidelines with respect to stability for static loadings. Information available for Jones Meadow Dam is insufficient to support analytical evaluation of the embankment stability. There is no information on shear strength of foundation or embankment materials and there is no stability analysis on file. The location of the phreatic surface in the embankment is unknown except for the previously mentioned line of plant growth above the downstream toe.

Photo 6 Seep area at south abutment. Note vegetative line along face of dam

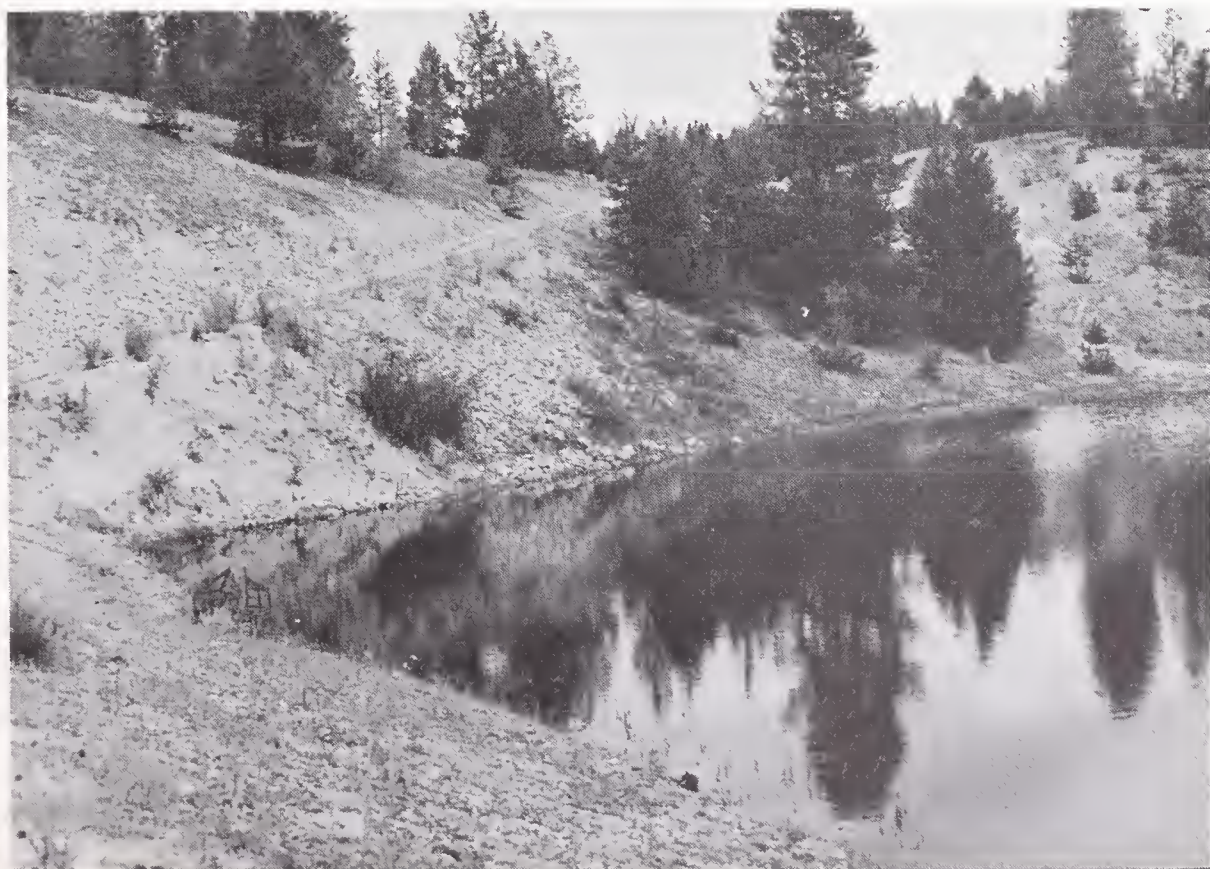
Photo 7 North abutment area upstream

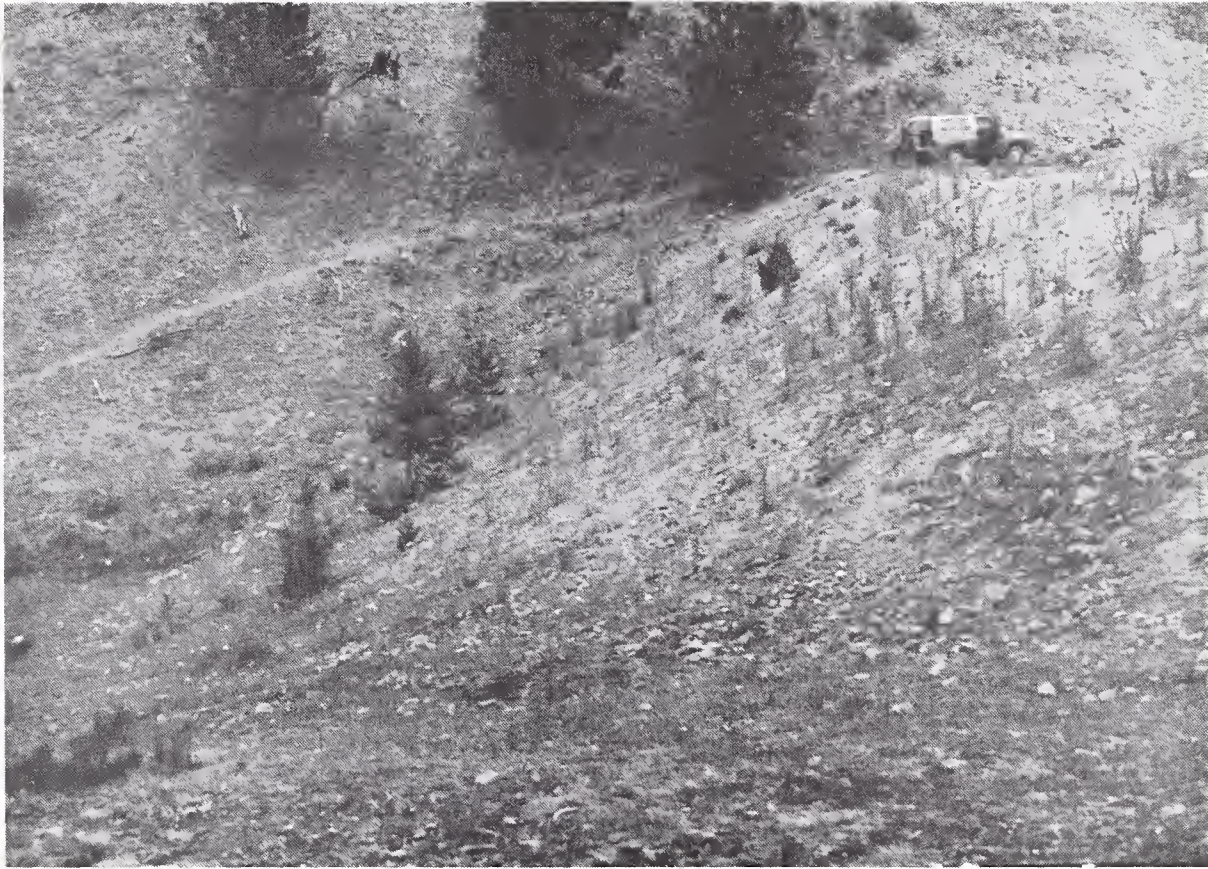
The July 17, 1980 field inspection did not detect any evidence of seepage in the right abutment or the alluvial foundation material. The elevation of the reservoir water surface at the time of the inspection was 116.3 feet project datum (approximately 4028.3 feet NGVD), 6.8 feet below the crest of the dam. A distinct demarcation in the density of grass vegetation on the downstream slope of the dam (Photo 6) about 11 feet above the toe at elevation 101.2 feet project datum (4013.2 feet NGVD) strongly suggests the presence of a zone of phreatic wetting below elevation 101.2 feet although the upper six inches of soil on the face of the dam was dry at the time of the inspection. Careful inspection of the embankment material around the outlet pipe at the downstream toe of the embankment revealed no evidence of seepage along the outlet.

Photo 8 North abutment area downstream

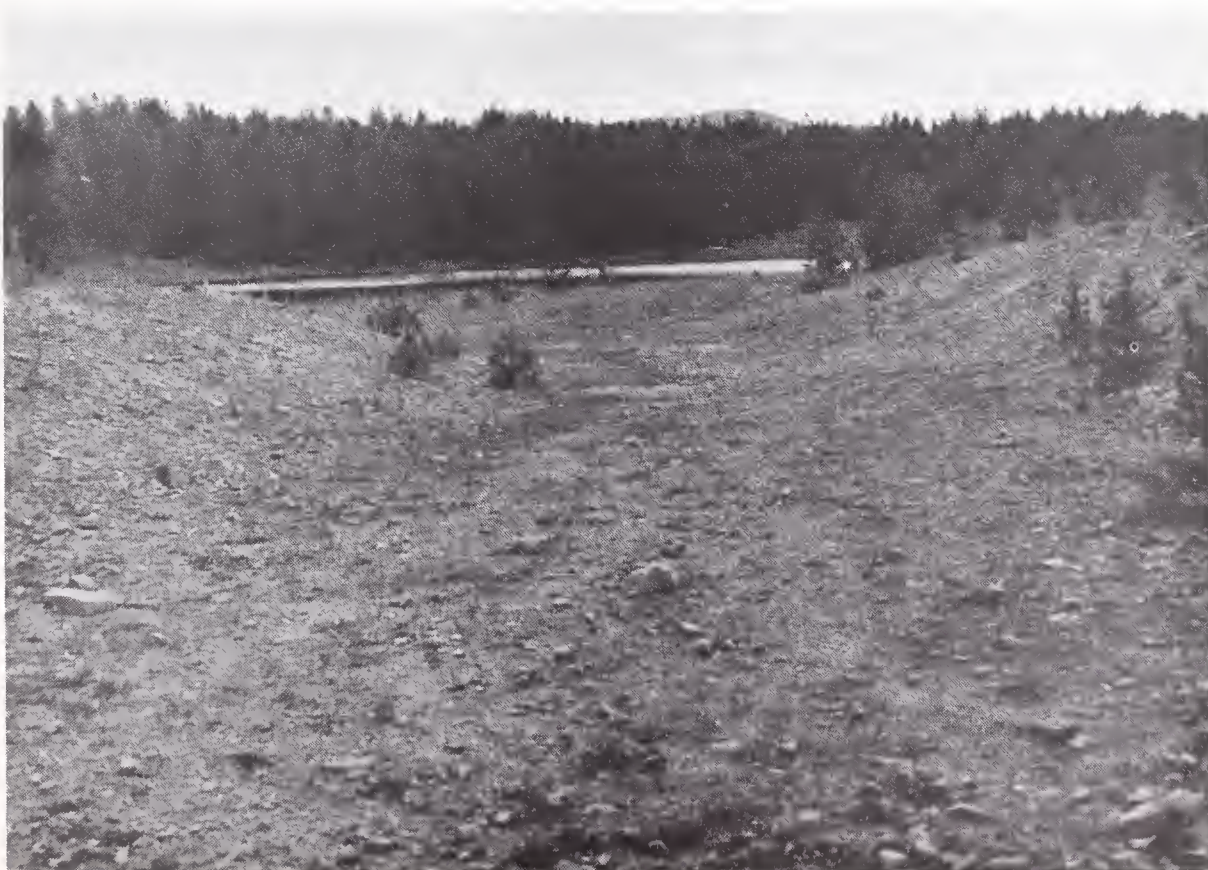
The emergency spillway is in very good condition and according to the owner has spilled water only once or twice since 1965. There is no means of controlling debris at the spillway but no debris was observed in the reservoir or along its shore.

Photo 9 Spillway approach channel looking toward Reservoir from axis of Dam

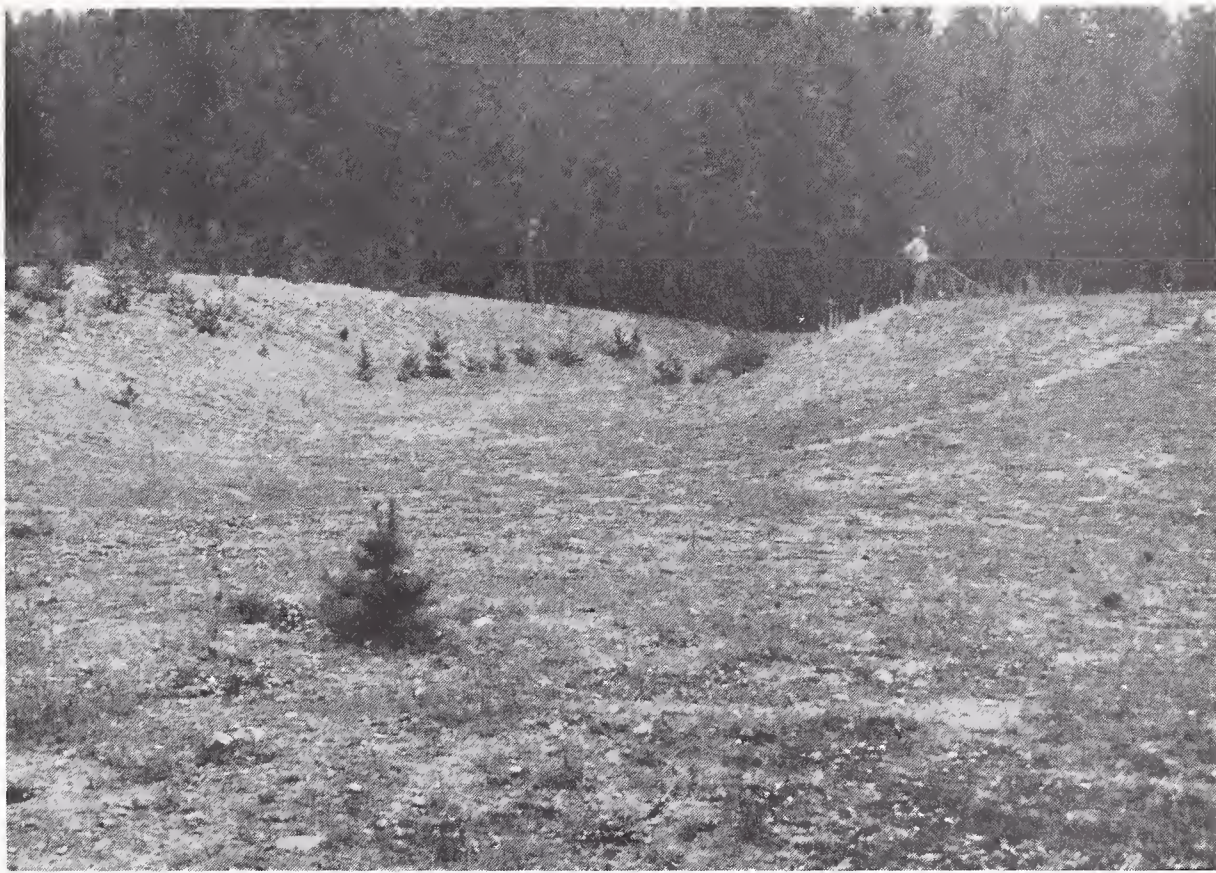
Photo 10 Spillway channel looking downstream. Man standing on centerline of Dam crest

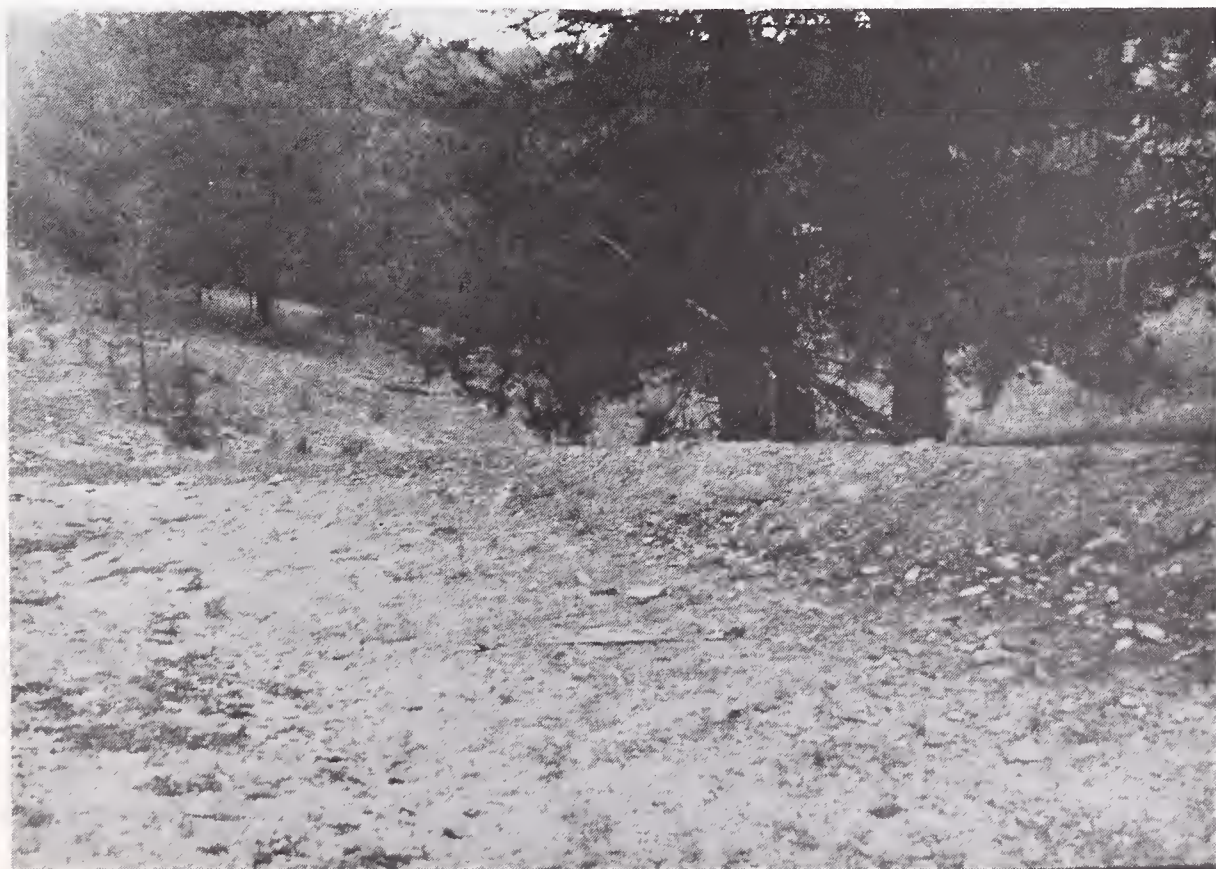
Photo 11 End of spillway chute where it discharges to natural draw

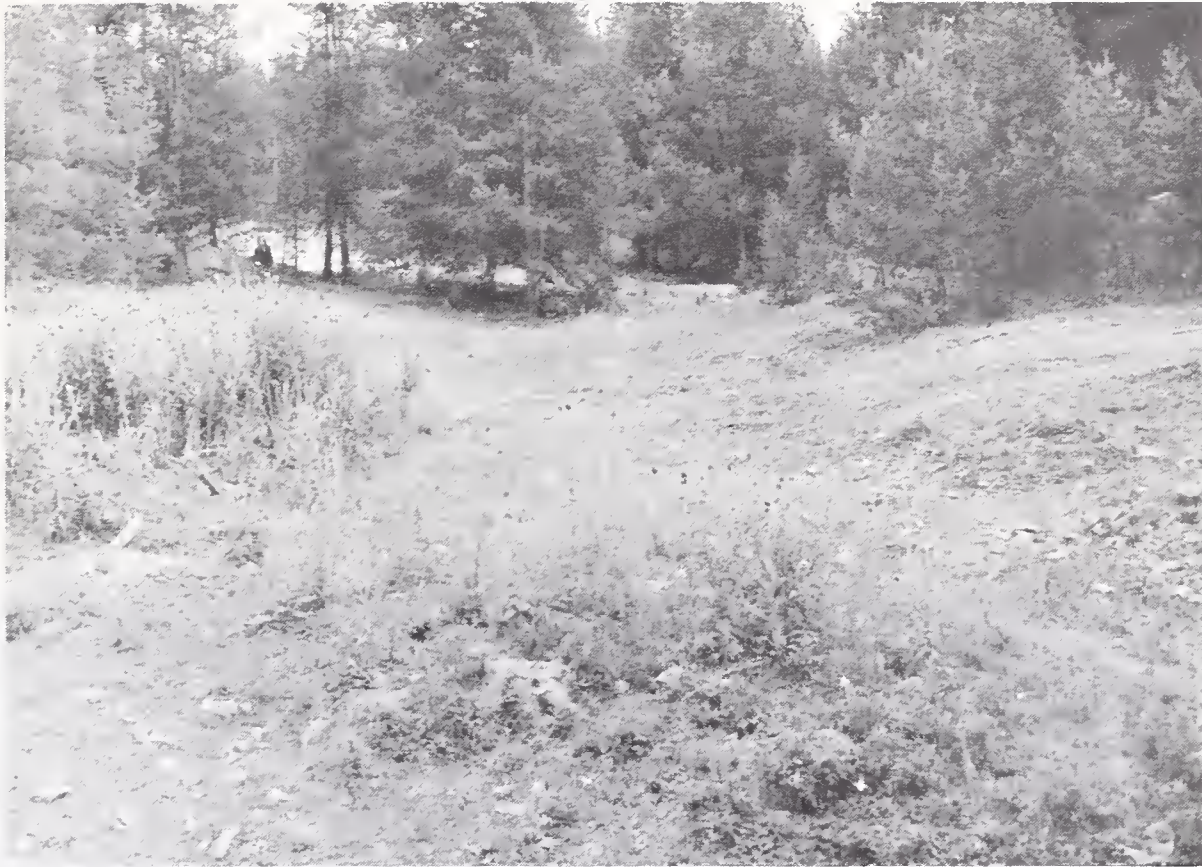
Photo 12 Looking up the natural draw to the spillway channel

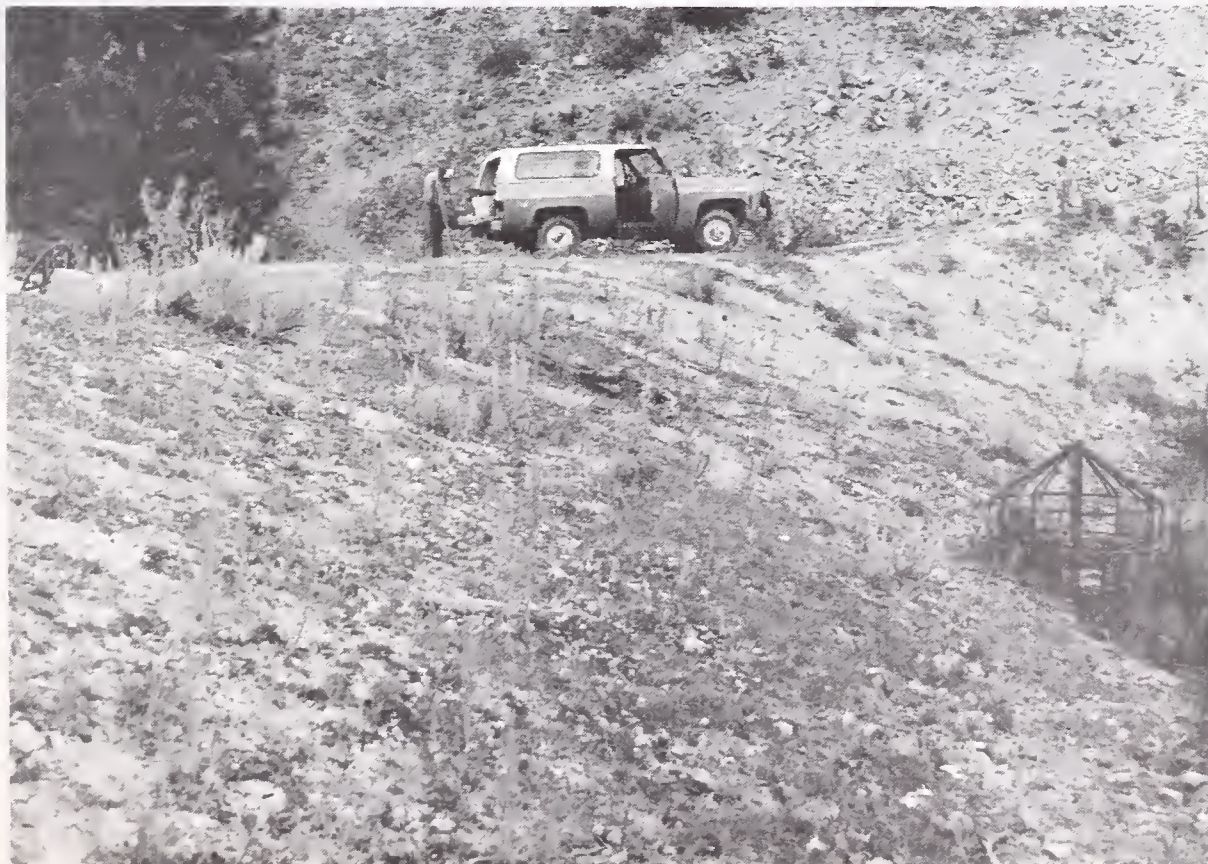
The outlet works appeared to be in good condition. The outlet conduit was not inspected because of its small size. The outlet gate was operated through its full range and is in good working order.

Photo 13 Principal spillway riser pipe and gate control wheel

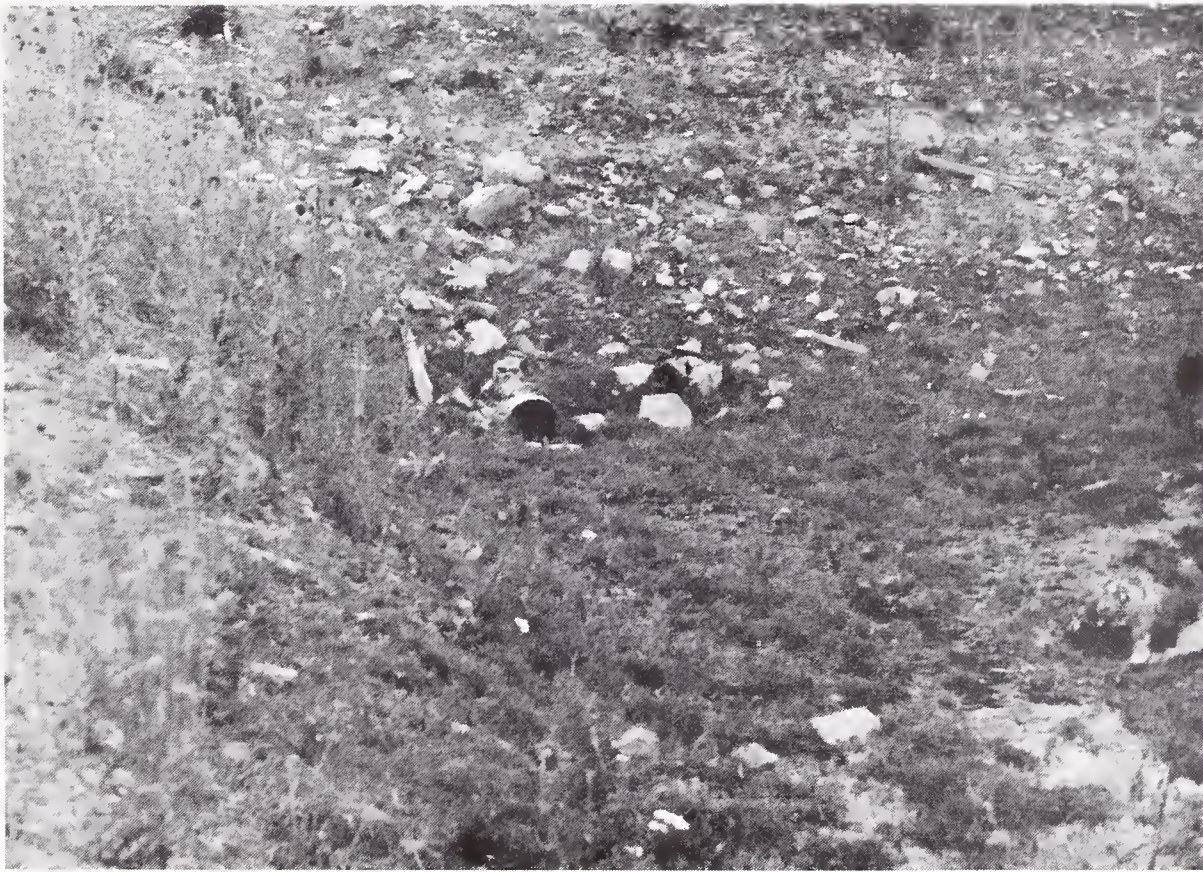
Photo 14 Outlet pipe at toe of Dam
